Investigation Report of Choshi Ohashi Bridge

June 2002
Mighty Corporation

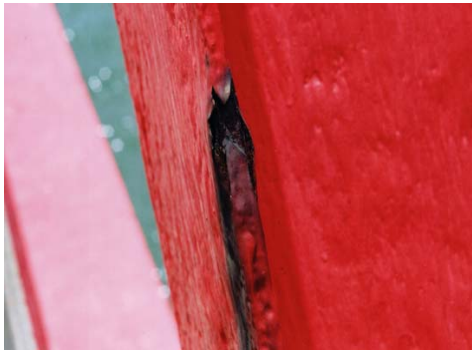
Many cracks were observed on the Fluorine Resin coated surface. (see Photos1 and 2)

Photo-1 Defective points of Fluorine Resin coating

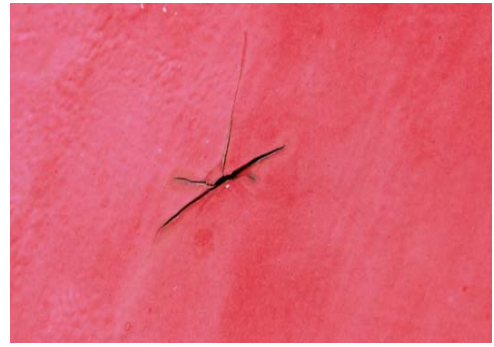
Photo-2 Crack of Fluorine Resin coating

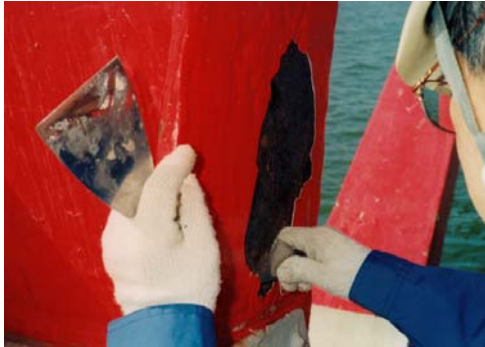
- 4) Mighty Coat CF-CP was applied to the top edge of steel plate. However, the cracks on the top side of the surface were not sufficiently closed. Rust formed in these areas and/or where the rainwater penetrated the cracks and

flowed to the lower edge of the structure and accumulated, as shown on Photo 3.

In this investigation, the flaking layer shown in Photo 3 was so wide that it could not be removed due to a short supply of Mighty Coat CF-CP at the site. The repairs performed because of the damages caused by the reasons mentioned above were limited to small areas due to time limitations, but can be seen in Photo 5 (corroded area) and Photo 7 (repair).

Photo-3 Removal of Fluorine Resin coating layer

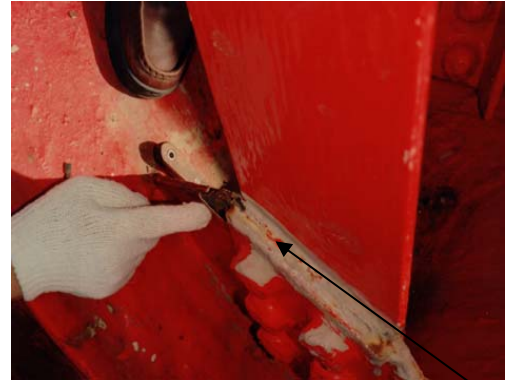
- 4) The rainwater and rust which formed between the Fluorine Resin coating and the steel structure flowed down through the clearance between the coating and the structure, and accumulated at the connection points of the gusset plate and slope structure, which caused additional corrosion at this point (see Photo 4).

- 2) Rainwater penetrated cracks on the Fluorine Resin coating and reached the steel structure and the rust surfaced through the Mighty Coat CF-CP and/or Fluorine Resin coating layers. As the result, it appeared that the rust formed on the Mighty Coat CF-CP as seen in Photo 4.

- 5) It appeared that rust also formed at the edge of gusset plate, as shown on Photo 4. Here, Mighty Coat CF-CP was applied without first removing the Fluorine Resin coating layer. Rust formed at the top edge of the gusset plate. As seen in Photo 4, the amount of Mighty Coat CF-CP was not sufficient. As a result, the red coloration of the Fluorine Resin coating was observed through the Mighty Coat CF-CP layer, which gave the appearance of corrosion on the surface of Mighty Coat CF-CP.
- 6) General observation indicates that Mighty Coat CF-CP was applied on the surface for corrosion prevention without consideration for the coating amount and without properly preparing the surface or removal of the heavy, flaking layer of existing corrosion.

Photo-4 Corrosion of gusset plate edge

Fluorine Resin coating

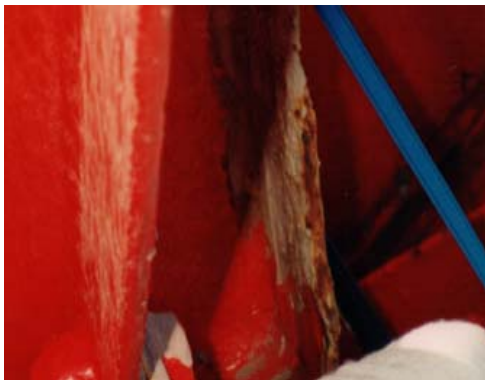
- 1) The adhesion between the Fluorine Resin coating and steel structure had been compromised, and when hammering lightly or applying light pressure to the surface, the coating flaked away. It was also easily peeled off in layers (see Photo 5)
- 2) After removing, it was clear that rainwater had penetrated into the gap between the Fluorine Resin coating and steel structure.
- 3) Due to the penetration of the moisture, the steel structure corroded. The

In Photo 5, it is clear that rainwater infiltrated the area between the steel surface and the Fluorine Resin. To repair this, it was necessary to remove all of flaked Fluorine Resin coating and, after cleaning the steel surface, Mighty Coat CF-CP was applied to the clean surface. Depending on the schedule to replace the existing bridge, some type of anti-corrosion work will be necessary to preserve the structure for its remaining years. If Mighty Coat CF-CP is applied for anti-corrosion, the following points need to be considered.

Photo-5 Corrosion under Fluorine Resin layer

The proper amount of Mighty Coat CF-CP, per the manufacturer's specifications, should be applied on the steel surface after removing the Fluorine Resin coating and thoroughly cleaning up the rust flakes. Mighty Coat CF-CP should not be painted over the flaking Fluorine Resin coating. If you paint it over the compromised Fluorine Resin coating, the steel surface will be continuously corroded by rainwater which will penetrate the imperfections in the Fluorine Resin layer. The following steps must be complied with.

- a) All flaking Fluorine Resin coating must be removed.
- b) Level 3 cleaning of floating and flaky corrosion should be completed after removing the layer.
- c) Remove the rust powder using a metallic brush or broom.
- d) Apply the proper amount of Mighty Coat CF-CP with a brush or roller, per the manufacturer's directions.

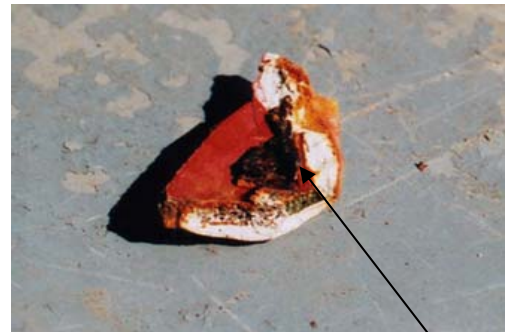
- 3) Mighty Coat CF-CP was applied to the bolt heads, where corrosion was observed. This may have occurred due to a possible short supply of Mighty Coat CF-CP. The Fluorine Resin coating was not removed and Mighty Coat CF-CP was applied on top of the original Fluorine Resin coating. In addition, there were fissures in the Fluorine Resin coating which were not closed with Mighty Coat CF-CP. This was established when the Mighty Coat CF-CP was removed from the bolt head, as shown on Photo 6.

Photo-6 Corrosion where bolt head was removed

Rust came up through the hole made by the shortage of Mighty Coat CF-CP

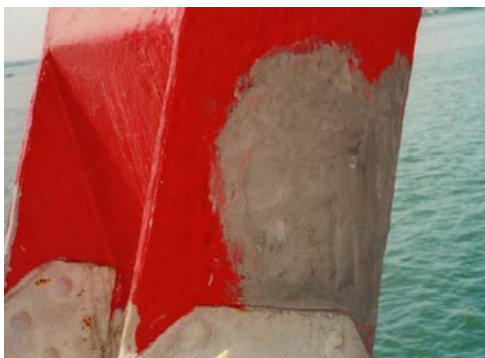
Mighty Coat CF-CP was applied to the deteriorated and corroded areas coated with Fluorine Resin paint, without first removing the Fluorine Resin paint. A typical example is seen in Photo 7. Here, Mighty Coat CF-CP was not applied directly on the steel surface. Additionally, as shown in Photo 5, Mighty Coat CF-CP was applied across the entire steel structure's edge, where the Fluorine Resin layer was flaking, but was not removed prior to applying Mighty Coat CF-CP. Some existing cracks in these areas were not filled prior to applying, or corrected with the application of, Mighty Coat CF-CP, so rainwater was able to penetrate these openings. Typically, rust formed on the areas coated with Mighty Coat CF-CP as follows:

Photo-7 After repainting with Mighty Coat CF-CP
