Steel Post Splash Zone
with Inorganic Rust Prevention Material
Construction Method Manual
(Mighty CF-SP)

Mighty Chemical Co., Ltd.

Steel Post Splash Zone with Inorganic Rust Prevention Materials Construction Method (Mighty CF-CP Method)

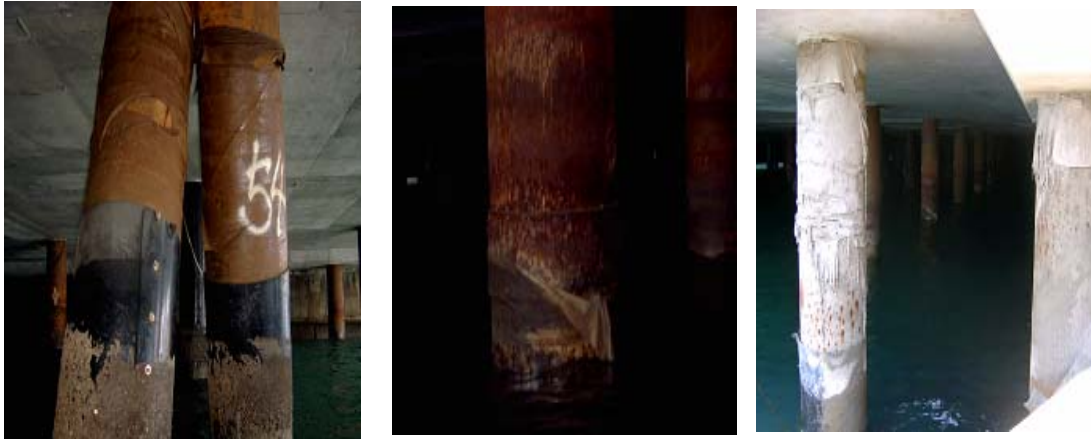
Diagram 1 Secular distortion of construction by petrolatum industrial method

Although it is very economical, it is vulnerable to impact and can rust easily at damaged sites. Moreover, the petrolatum tape can be infiltrated by seawater, making petrolatum flow out, and causing the corrosion of the entire steel pipe in the splash zone, as well as in locations.

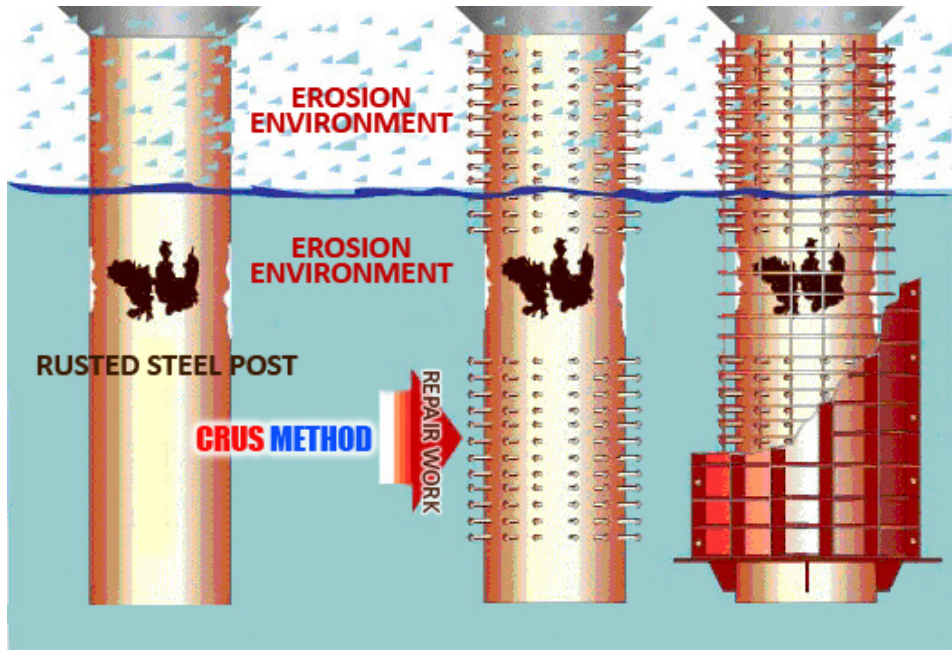
Diagram 2 CRUS Method Concept Chart

Among the harbor's steel structures, this method aims at anti-corrosion in the steel pipe pile, sheet piles, and the steel pipe sheet piles. After welding the reinforced concrete with an underwater stud welding on the surface of the metal, and setting up the steel board on the surface of the outside instead of the formwork, it is necessary to pour the cement mortar between the steel board and the steel structure, which reinforces the structural integrity.

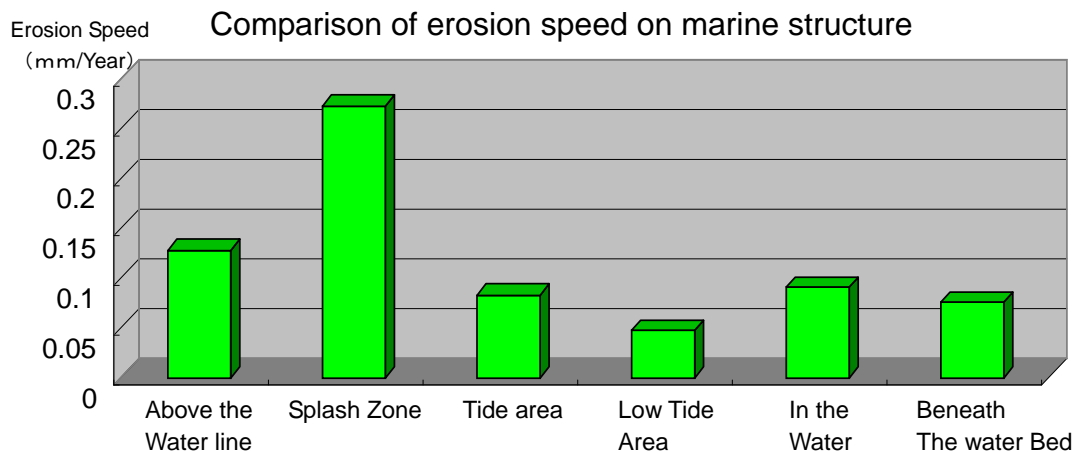
Diagram 3 Corrosion speed comparison in oceanic steel pipe stake

The corrosion rating is very high, especially around splash zone. The speed of rusting at splash zone is six times faster than at the tidal area and three times than the area under water. There are many corrosion problems even though the splash zone is protected by heavy corrosion protection paint or Organic Material Lining Construction method.

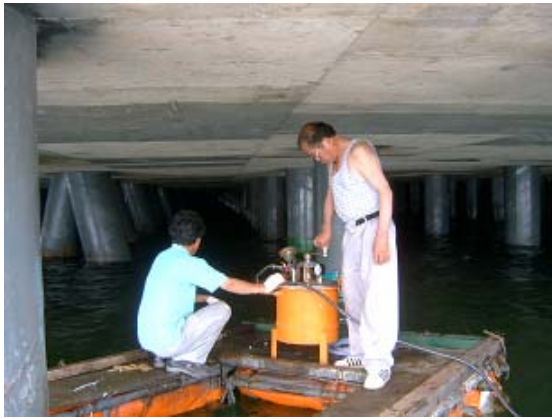
Diagram 4 Injection of Mighty CF-CP

Injection of Mighty CF-CP needs to be performed carefully; closely monitor that Mighty CF-CP is being filled through transparent polycarbonate formwork while the material is pumped in from the injection hole at lower part of pillars. After you confirm that Mighty CF-CP is pouring out from air vent at upper part of pillars, the

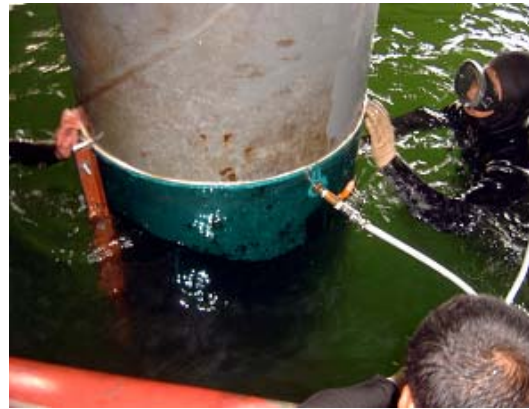
Diagram 5 Confirmation of exhaust at top vent holes

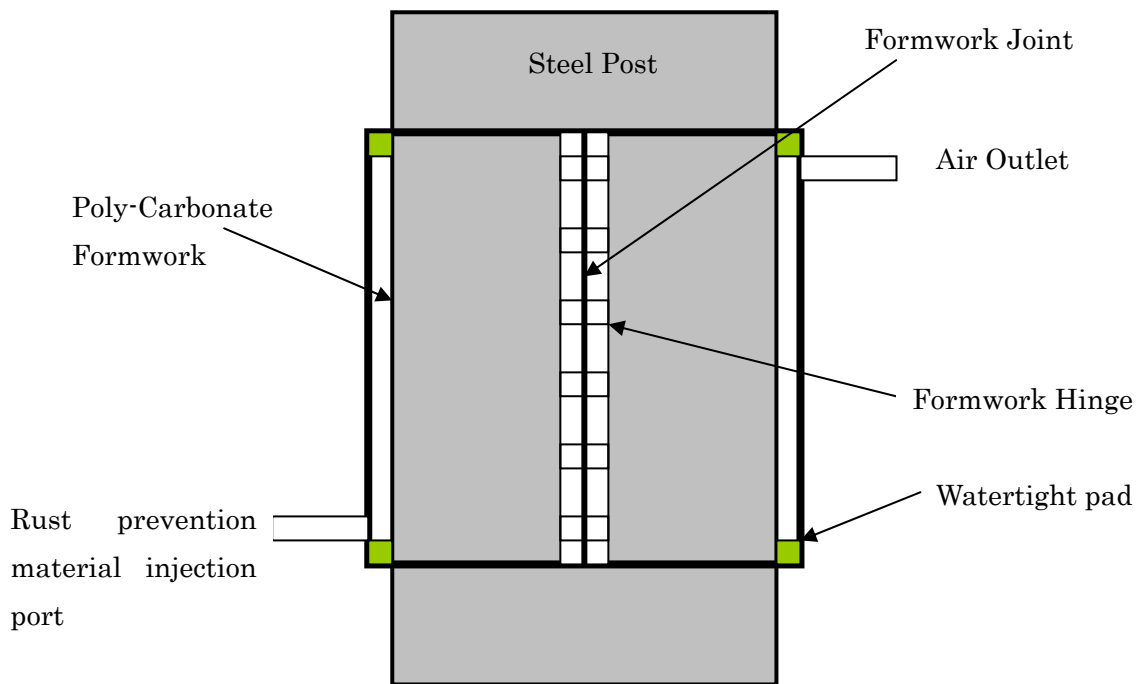
Diagram 6 Summary of Mighty CF-CP Construction Method

For the formwork, Mighty CF-CP has adopted formwork made of polycarbonate resin (PC), which is excellent for weather resistance and transparent. There is the pad,

reinforcement, the anti-rust injection port, and the air outlet to maintain the water-tightness of the formwork. The formwork was set around the splash zone of the steel pillars. Inject Mighty CF-CP containing rust prevention paste with salinity absorbent through the lower injection port. Mighty CF-CP is designed to protect the steel structure from corrosion by maintaining a strong alkaline level.

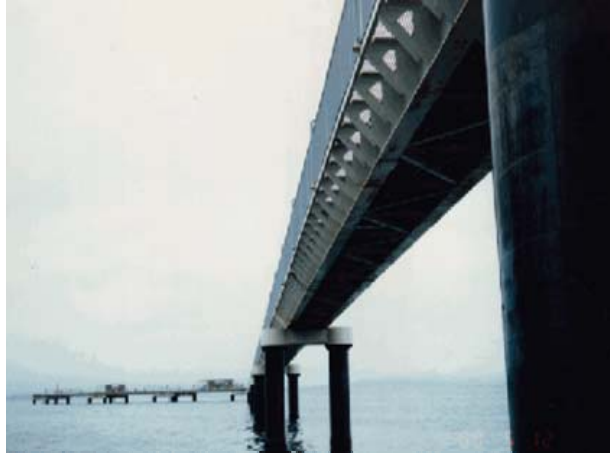
Diagram-7 Shimonoseki Fishing Park

Fishing Park was constructed by the City of Shimonoseki for fishing in 1984. As you can see from Diagram 7, it consists of 300m long straight pier stretched out to the water and 100m deck portion from the tip of pier. The water depth at the deck portion reaches over 10m deep. There is a long handrail running along the pier, and people can walk to the deck area from the land. Mighty CF-CP was applied to this structure as a Heavy Rust Prevention Coating material in 1984. 1.5 kg/m² of Mighty CF-CP was applied on the beams and girders of pier, and then a chlorinated rubber top coat was applied up to 300 µm of thickness. The pier subfloor slab and the guardrails consist of expanded metal which was galvanized with zinc. However, those structures corroded severely, and were re-painted with Mighty CF-CP.

Following is information on the Mighty CF-CP Heavy Rust Prevention Project for this facility. The Rust Prevention material coating on the Pier structure was applied on land in September 1984. Mighty CF-CP was applied on the surface of steel structure, covering even any remaining red rust. After a simple cleaning procedure, Mighty CF-CP was sprayed over the surface where red rust remained (see Diagram 8, 9, and 10). You can see the light red color surface after the first coat of Mighty CF-CP over the red rust. Following the initial application, a paint spray gun was used to apply Mighty CF. After the two coats of Mighty CF dried completely, two coats of Chlorinated rubber paint were applied to complete this project.

Shimonoseki Fishing Park was built in a very severe environment. There has been no major repair work done over 24 years since it was constructed In September 1984, due to the rust prevention performance of Mighty CF-CP. However, some problems have been found, and those were taken care.

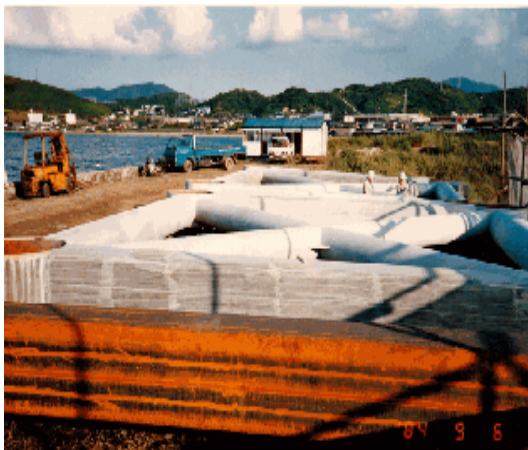
Diagram 8 Coating on joint part

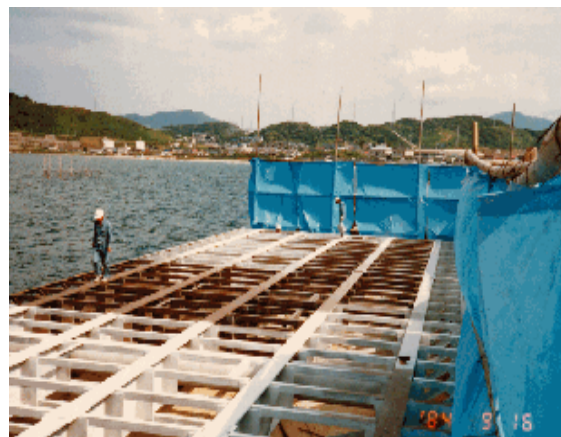
Diagram 9 Setting subfloor slab of beam and pier

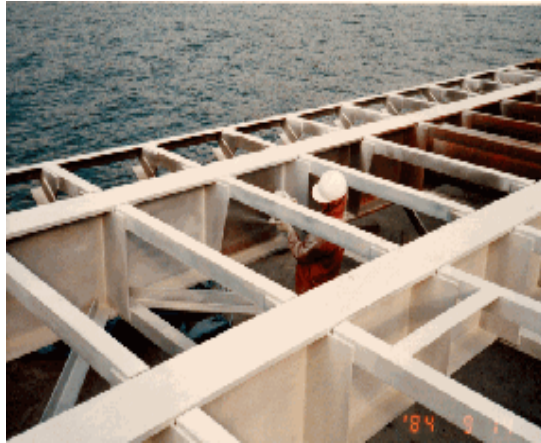
Diagram 10 Applied by Spray Gun

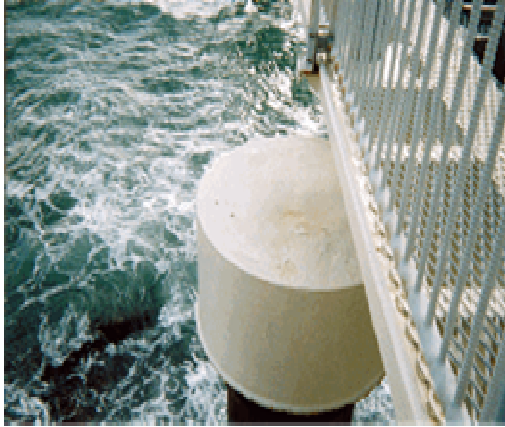
Diagram 11 Top of the pillar post

In order to confirm that Mighty CF-CP has the ability to change red rust to black, some objective tests were conducted at the top head of the steel piles in September 2006 by COSMO Engineering Co. Diagram 11 shows the top of the steel pile used for this test. At first, the top coat was lightly sanded down using a sander disk, to check the condition underneath (see diagram 12). It was confirmed that the condition of Mighty CF-CP is still healthy, and the bonding strength testing measured 1.4N, even 23 years after construction. Diagram 13 shows the top coat removed further to expose the steel surface of the pillar. According to this test, it shows the red rust shown in photo 8 was changed to a stable black rust. This is evidence that the red rust will be changed to the black stable rust through the high alkaline nature of Mighty CF-CP.

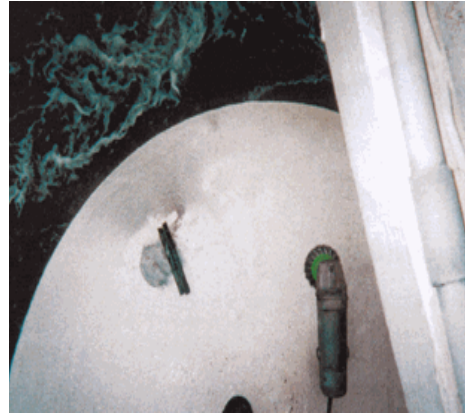
Diagram 12 Removing Top Coat

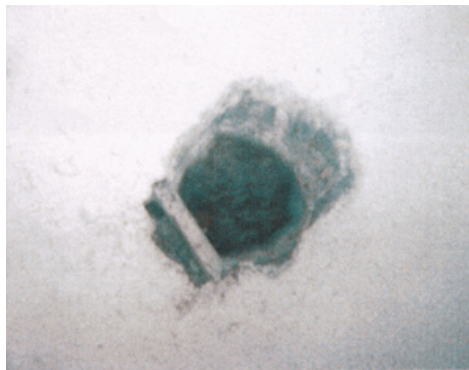
Photo 13 Removed Mighty CF-CP

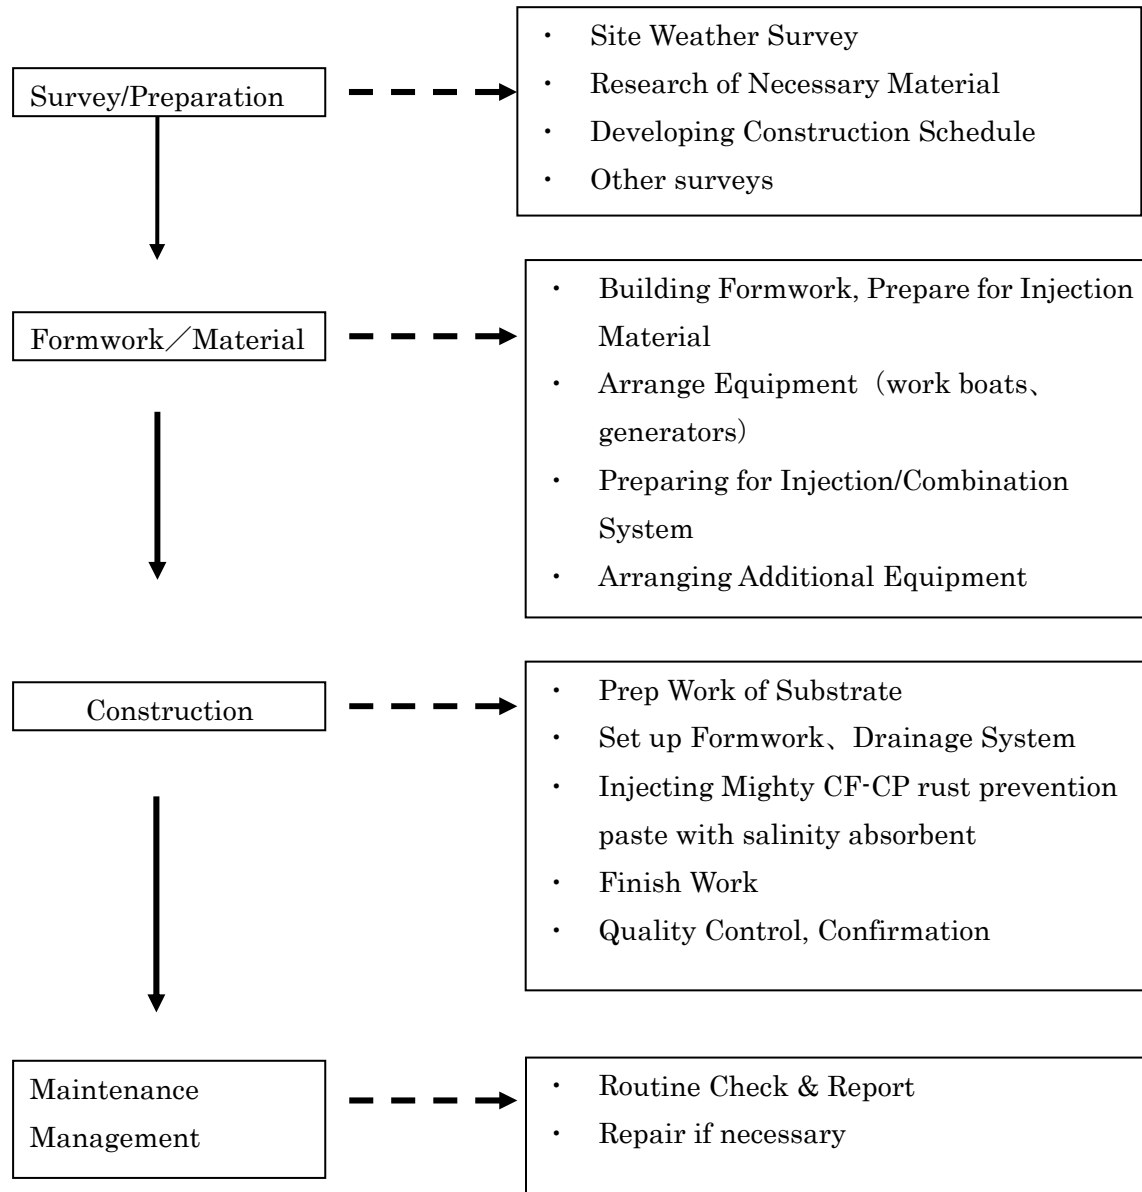
4 – 1 Construction Flow

Here is a general construction flow of Mighty CF-CP.

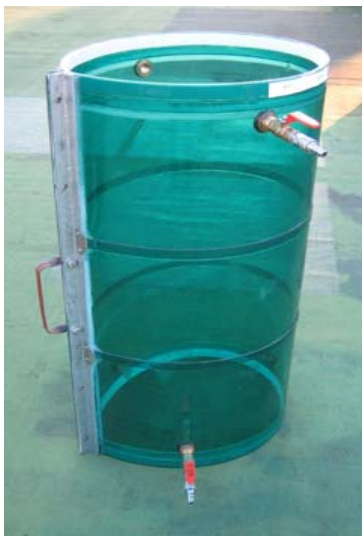
Diagram 14 Before set up

Polycarbonate formworks have 2 to 3 air vent holes at the upper part, and 3 to 4 injection holes for Mighty CF-CP at lower part. There are reinforcement sheets, bolts, and water pads at the joint. Water pads are 10 mm thick before installation, and become 3mm to 5 mm thick after they are installed. They are attached to the steel pillar tightly, and create 3mm to 5mm gap between formwork and Steel Pillar.

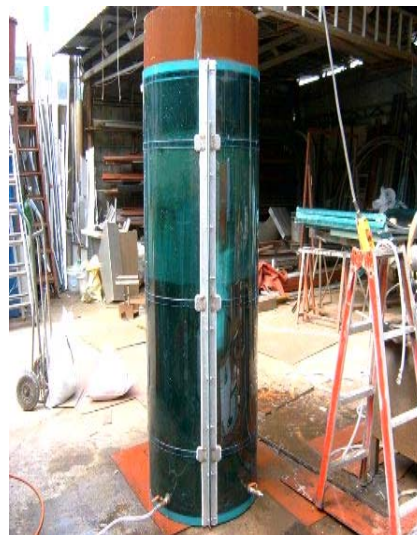
Diagram 15 Closing formwork on land

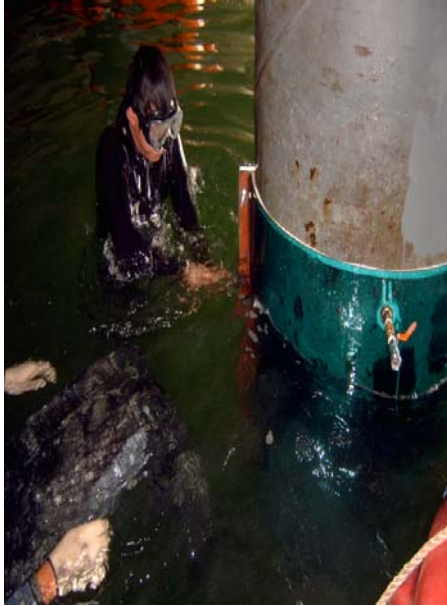
Diagram 16 Setting up the up formwork around the pillar

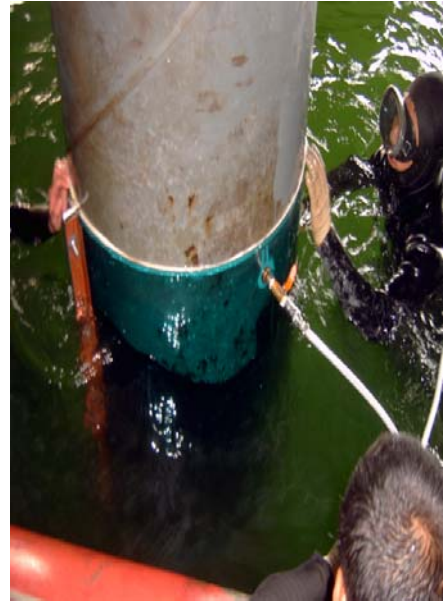
Diagram 17 Removing water from the formwork

Once the formwork is installed, water must be removed. To remove water while the top air vents are open, water can be pumped out from the lower part of pillars, through the injection holes for Mighty CF-CP. After the water is completely removed, confirm there are no leaks in joint areas and top and bottom water pads. This completes the set up of the formwork.

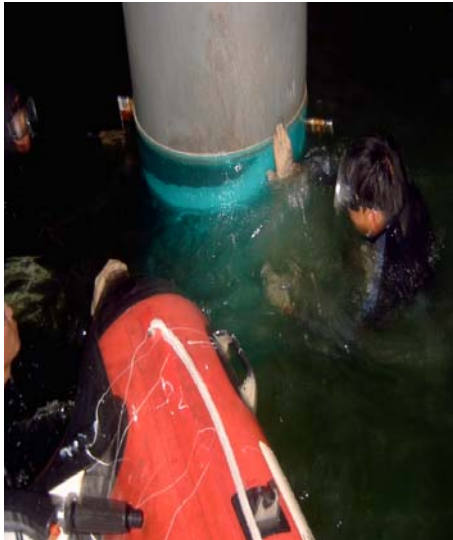
Diagram 18 upper left area needs to be filled

If pillars are not completely filled with Mighty CF-CP, the color of the transparent polycarbonate formwork is not white. Continue injecting Mighty CF-CP until all the formwork turns white and Mighty CF-CP is pouring out from the vent hole. The work needs to be re-checked after 48 hour,, and any excess materials around the vent holes needs to be removed.

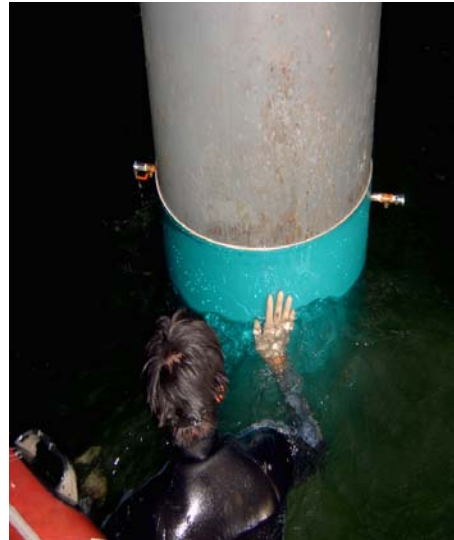
Diagram 19 completion of injection
